RECALL SAFETY NOTICE

2021 & 2022 SCHWINN VOADOR AND KETTLE VALLEY EBIKES

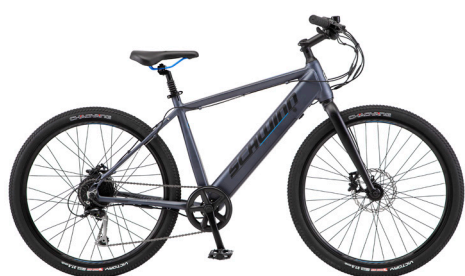
VOADOR — MEN'S FRAME STYLE

S7528SMAUS	Size: 40 small	GREY
S7528MDAUS	Size: 47.5 medium	GREY
S7528LGAUS	Size: 53 large	GREY

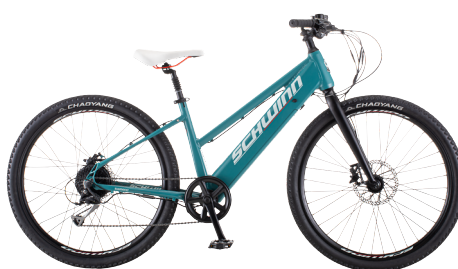
VOADOR — WOMEN'S FRAME STYLE

S7529SMAUS	Size: 40 small	TEAL
S7529MDAUS	Size: 47.5 medium	TEAL

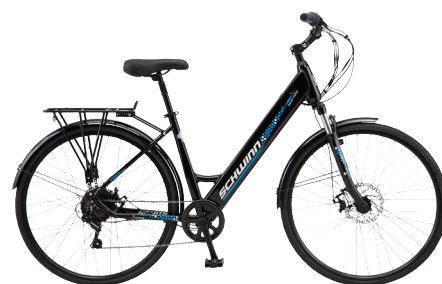
VOADOR — STEP THRU FRAME STYLE

SCS7519AUS	Size: one size	BLACK
------------	----------------	-------
